## X.G. Yang, D.L. Duan, S.L. Jiang\*, S. Li and H.C. Zhang

# Preparation and erosion-corrosion behavior of polyetheretherketone (PEEK)/nickel foam co-continuous composites

DOI 10.1515/secm-2015-0449

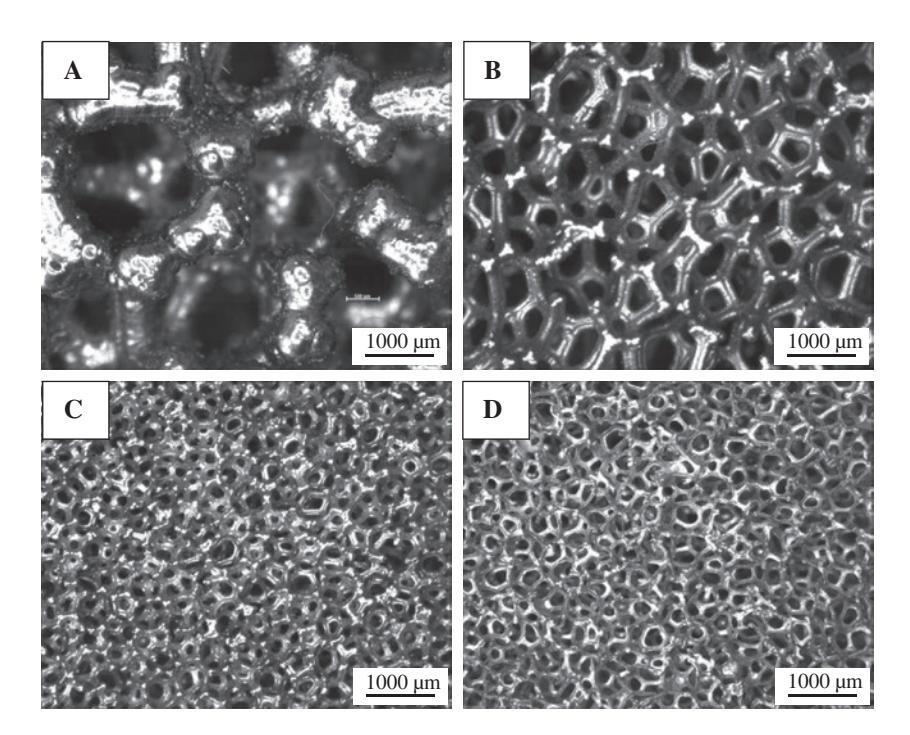
Figure 1: Ni foams used in the work: (A) 25 PPI, (B) 50 PPI, (C) 100 PPI-1, and (D) 100 PPI-2.

Ni foams used in this work were produced by Zhuoer New Material Co., Ltd. Four kinds of Ni foams with different average aperture, porosity, and pores per inch (PPI) values were used. The morphologies and properties of the foams are shown in Figure 1 and Table 1, respectively.

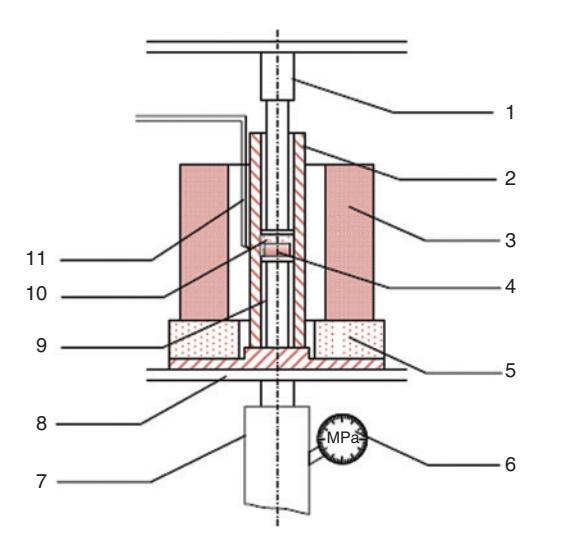
The molding equipment is shown in Figure 2. Hydraulic jack was used to provide the desired operating pressure and its maximum pressure can reach 60 MPa. A high-power heating furnace was used to heat the mold. The thermocouple located outside the wall of the mold was used to detect the operating temperature. To make the hydraulic jack work normally, a thermal insulation material was placed between the oven and the base plate

**Figure 2:** Schematic of the preparation device: (1) upper mold, (2) outer mold, (3) oven, (4) Ni foam, (5) heat-insulating material, (6) gas-pressure meter, (7) jack, (8) base plate, (9) lower mold, (10) PEEK, and (11) thermal couple.

to reduce the heat transfer from the furnace to the base metal. The manufacturing process is described as follows:

- 10 g PEEK powder was measured and transferred into the mold (this is 20% more than the calculation value as overflow during the extrusion process). The PEEK powder was pressed into blocks under 10 MPa to remove the air in the powder.

- The Ni foam sample was placed under the PEEK bulk, and the mold was transferred into the oven. To ensure the molten state and keep the low viscosity of the PEEK powder, the mold was heated to 400°C at a heating rate of 10°C/min and kept warm for 5 min.

- 4 MPa stress was exerted on the internal material using a hydraulic jack. During extrusion, the speed should be slow and steady to keep the PEEK pressing into the Ni foam evenly.

- When the upper part of the mold was approaching the Ni foam sample, pressing was stopped and pressure was applied for 5 min to keep the molten PEEK flowing into the Ni foam and filling the voids. The period under high temperature should not be too long in case the polymer molecular chain will decompose or cross-link.

- The chamber was gradually cooled to 210°C in air. This temperature was maintained for 40 min to improve PEEK crystallization.
- The composite specimen was demolded when the temperature decreased to 80°C and was collected for the erosion-corrosion tests.

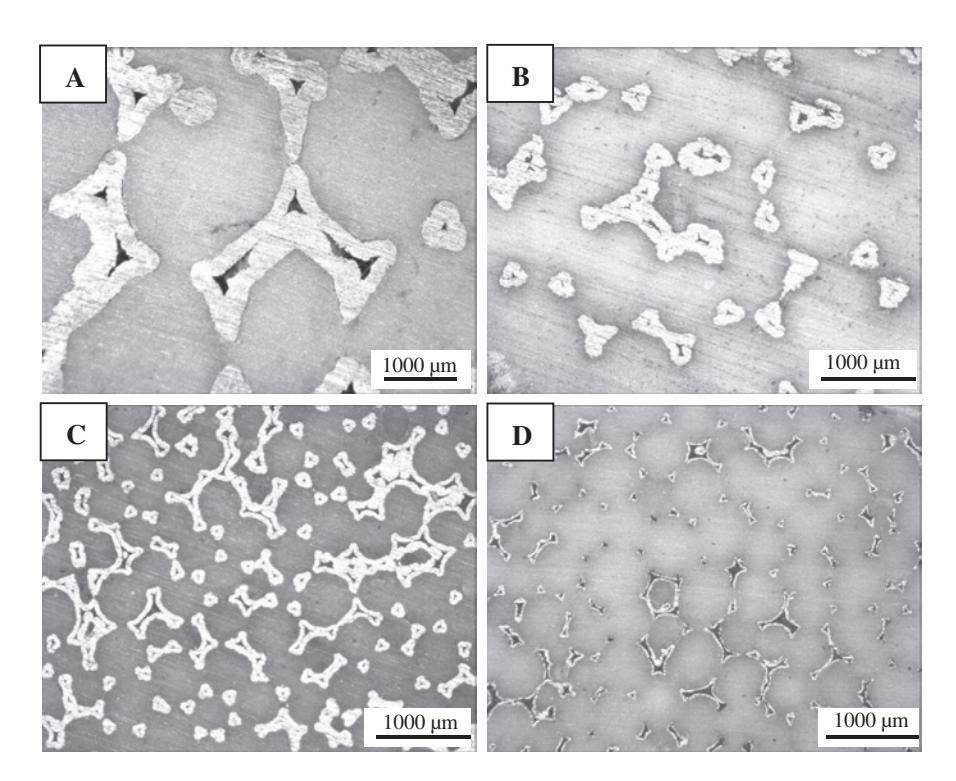
The morphologies of PEEK/Ni foam composites are shown in Figure 3. The insets in the resulting composite materials show that Ni foam is effectively encapsulated by PEEK polymer. The fabricated composites exhibit a topologically uniform microstructure and an interconnected network structure. However, hollow metallic struts distributed throughout the composite body can be observed, which indicates that PEEK cannot fill the interior of the metallic struts. Therefore, the preparation method should be improved further.

Figure 3: Morphologies of PEEK/Ni foam composites with Ni foams of different PPI values: (A) 25 PPI, (B) 50 PPI, (C) 100 PPI-1, and (D) 100 PPI-2.

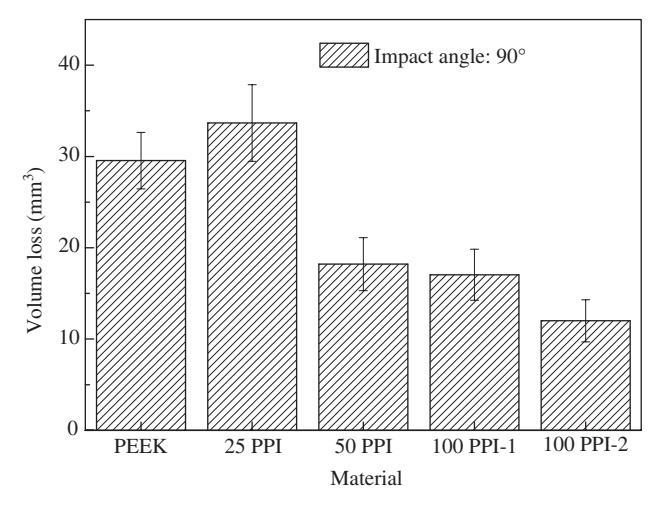
The volume loss results of the different materials after 2 h of erosion-corrosion test in tap water with 1 wt% H\_SO, and 5 wt% quartz particle (275 mesh) with a jet velocity of 30 m/s and an impact angle of 90° are shown in Figure 4. The maximum volume loss occurred in the PEEK/Ni25 composite, in which Ni foam exhibited the lowest porosity and highest bulk density. Figure 3A shows large struts in the PEEK/Ni25 composite, which can lead to additional turbulence during erosion-corrosion tests [21]. Under normal impact conditions, the impact energy is mainly dissipated in roughening the target surface. The roughening process includes a high degree of plastic deformation of the target materials under compressive and tensile stresses. The Ni segment was coarser than the PEEK site (Figure 5A and A'). No stripping was observed between Ni foam and PEEK in all four composites after the erosion-corrosion test (Figure 5A, A', B, B', C, C', D, and D'), which indicates the perfect combination of these two phases during the preparation and testing processes. In this work, the advantage of Ni in the composite is its higher impact strength than that of PEEK, which is beneficial to the mechanical component of erosion-corrosion [22, 23]. However, PEEK is better than metallic Ni in acid media in the chemical damage component. Additional volume loss caused by the corrosion component of the PEEK/Ni25 composite is more than the decreasing volume loss caused by the mechanical component because of the high proportion of Ni phase; thus, the total volume loss of the PEEK/Ni25 composite is higher than that of pure PEEK. For the other three composites, the proportion of Ni foam is considerably lower than that in the PEEK/Ni25 composite (Table 1), which reduces corrosion. In contrast, the mechanical resistance supplied by the three Ni foams is not less than that in the PEEK/ Ni25 composite because of their thin walls (Figure 3) and interconnected 3D structure. Consequently, the additional volume losses caused by the corrosion component are less than the decreasing component caused by the high strength of the three composites; hence, their total volume loss is lower than that of pure PEEK. The PEEK/Ni100-2 composite exhibits the best erosion-corrosion resistance because of the highest strength efficiency and lowest corrosion rate of thin Ni foam.

**Figure 4:** Volume loss results of the different materials with an impact angle of 90°.

Ni struts in PEEK can enhance its erosion-corrosion resistance in water/acid/particle media under an impact angle of 90°, except for the case in which the additional chemical corrosion damage is higher than the decrease in mechanical erosion damage. This phenomenon occurs at low PPI with thick Ni foam walls.

PEEK/Ni foam composites, except PEEK/Ni25, have lower volume losses than pure PEEK under normal impact. On the one hand, the Ni phase exhibits serious deformation (Figure 5A'-D'), which can absorb impact energy from quartz particles. On the other hand, impact energy can disperse along the Ni network. Thus, the Ni foam can reinforce PEEK under normal impact conditions.

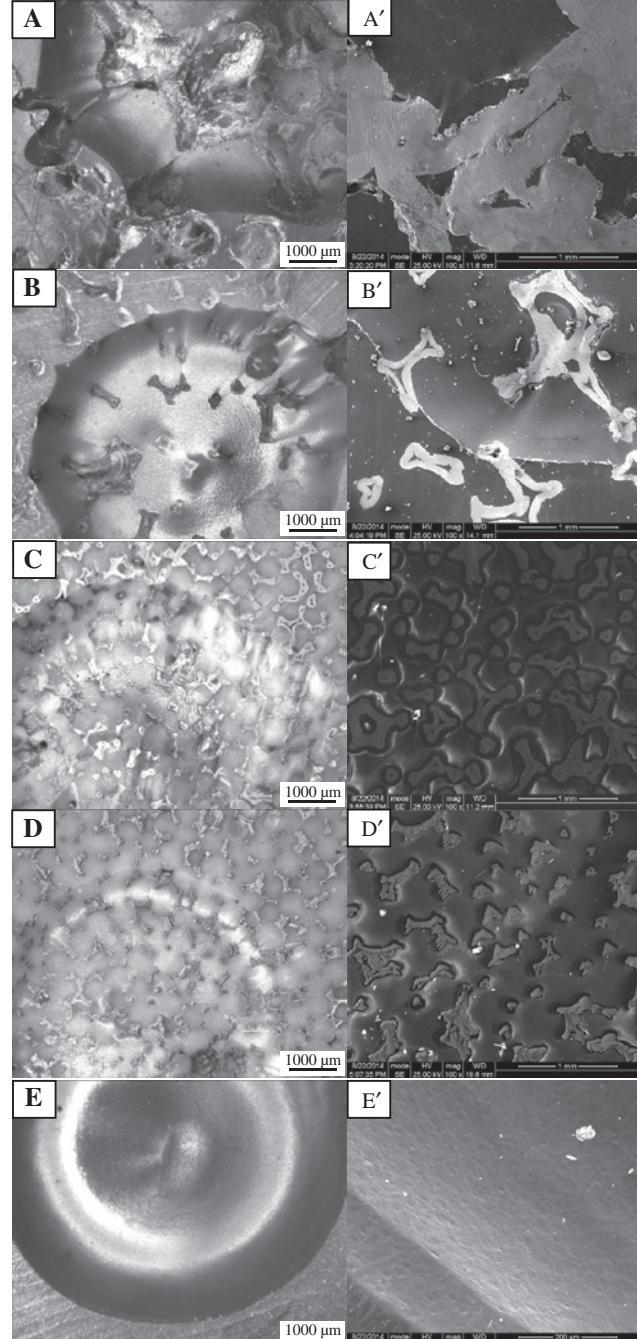
**Figure 5:** Morphologies of PEEK/Ni foam composites and pure PEEK after erosion-corrosion test with an impact angle of 90° observed using optical microscopy (A–E) and SEM (A'–E'): (A and A') PEEK/Ni25, (B and B') PEEK/Ni50, (C and C') PEEK/Ni100-1, (D and D') PEEK/Ni100-2, and (E and E') PEEK.

of PEEK from the impingement sites. After a given deformation, stress in PEEK exceeds its strength. Small microfractures may develop within PEEK, which causes small pieces of the material to peel off (Figure 5E'). The impact of the 30° impingement angle differs from the normal impact because of the onset of the microcutting and microploughing mechanisms. The deformation of the material is similar to that under normal impact but with additional cuts and ploughs [24], which result in chip removal in PEEK (Figure 7E'). The perpendicular component of the initial energy decreases with the reduction in impingement angle; thus, the volume loss of PEEK under oblique impact is significantly lower than that under normal impact. For the same reason, the PEEK/Ni foam composites have lower volume loss under oblique impact than under normal impact. These results seem contradictory to the behavior of PEEK and its short fiber-reinforced composites in solid particle erosion characterized by Harsha et al. [25], in which pure PEEK exhibited peak erosion at an impingement angle of 30° as well as ductile erosion mechanism. However, in this liquid-particle system, even for ductile materials, the erosion rate can increase with impact angle or exhibit another damaged peak in addition to the one under 90° [26].

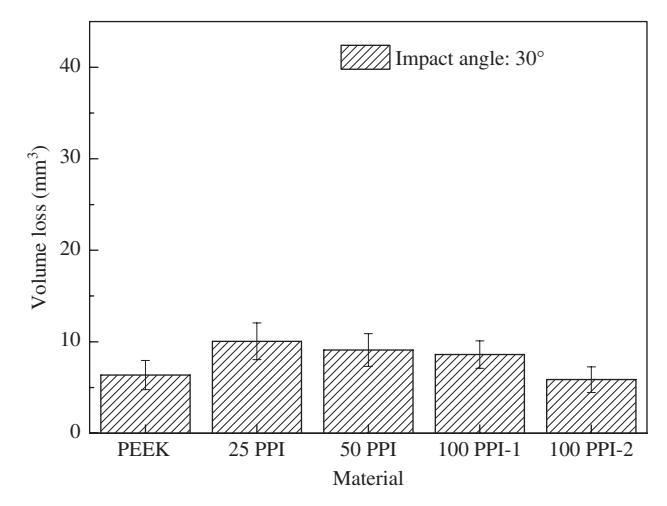
The volume loss results of the different materials after 2 h of erosion-corrosion test in tap water with 1 wt%  $H_2SO_4$  and 5 wt% quartz particle (275 mesh) with a jet velocity of 30 m/s and an impact angle of 30° are shown in Figure 6. The total volume loss rate is significantly lower than that for the test with an impact angle of 90°.

**Figure 6:** Volume loss results of the different materials with an impact angle of 30°.

In this case, although the ductile Ni foam phase is easily cut and ploughed by quartz particles, impact energy can be dispersed along the Ni skeletons. Therefore, the Ni foam phase may be slightly beneficial to the mechanical component of the erosion-corrosion of composites. For the chemical damage component, Ni is not as efficient as PEEK in the acid medium with either normal or oblique impact. Consequently, the total volume loss of the three composites is higher than that of pure PEEK. Only the total volume loss of PEEK/Ni100-2 does not demonstrate a notable difference with pure PEEK because of its low Ni foam proportion.

The composites, except PEEK/Ni100-2, have higher volume losses than PEEK under oblique impact. The

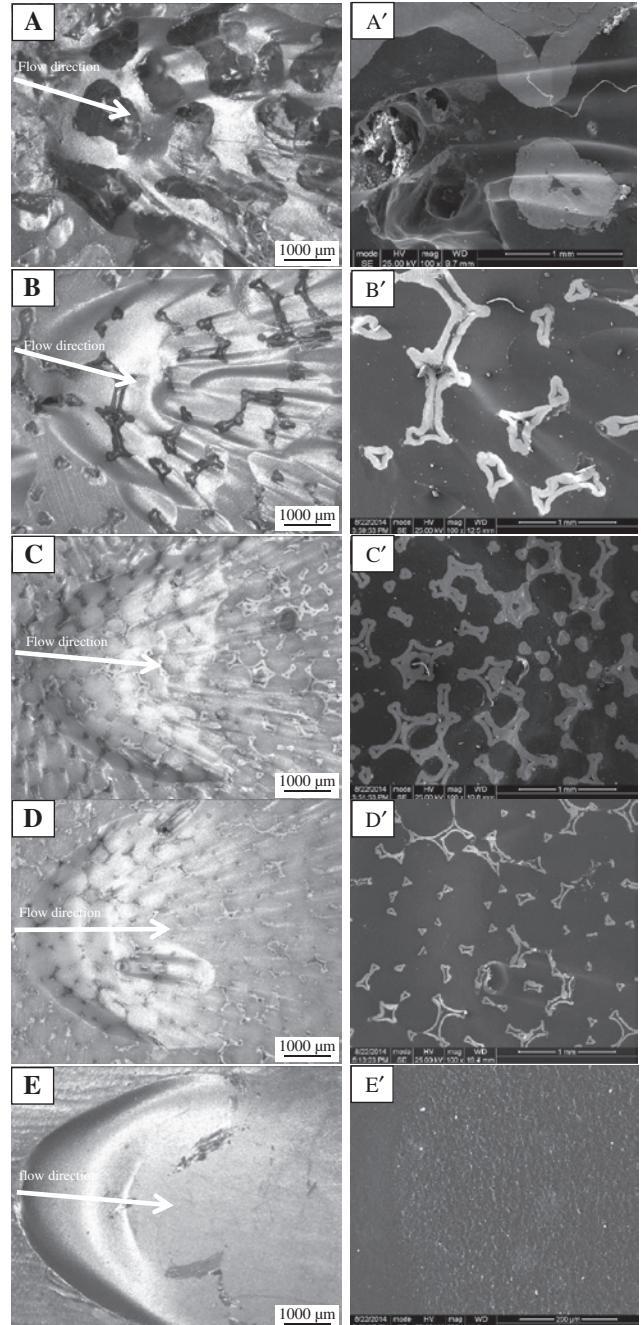
Similar to the results of the 90° impact, no stripping was observed between Ni foam and PEEK in all four composites after the erosion-corrosion test (Figure 7A, A', B, B', C, C', D, and D'). This finding indicates the perfect combination of these two phases during the preparation and testing processes. Maximum volume loss was also observed in the PEEK/Ni25 composite, which is similar to the results of the test with the impact angle of 90°. A deep and long pitting tail along the flow direction can be observed on the damaged site of the PEEK/Ni25 composite (Figure 7A and A') because of the preferential damage of the ductile Ni phase under low impact angle. The pitting tail becomes shallow and short as Ni phase proportion decreases (Figure 7B, B', C, C', D, and D'). For pure PEEK, nearly no pitting tail can be observed on the damaged site (Figure 7E and E'). Ni struts in PEEK cannot enhance the erosion-corrosion resistance of PEEK in water/acid/particle media under a low impact angle.

**Figure 7:** Morphologies of PEEK/Ni foam composites and pure PEEK after erosion-corrosion test with an impact angle of 30° observed using optical microscopy (A–E) and SEM (A'–E'): (A and A') PEEK/Ni25, (B and B') PEEK/Ni50, (C and C') PEEK/Ni100-1, (D and D') PEEK/Ni100-2, and (E and E') PEEK.
